FDN4 Penetration of Plasterboard Fire Walls

STRUCTURAL STEEL MEMBERS PENETRATION OF PLASTERBOARD FIRE WALLS

by I. D. Bennetts¹, K. Moinuddin² and D. J. Proe²

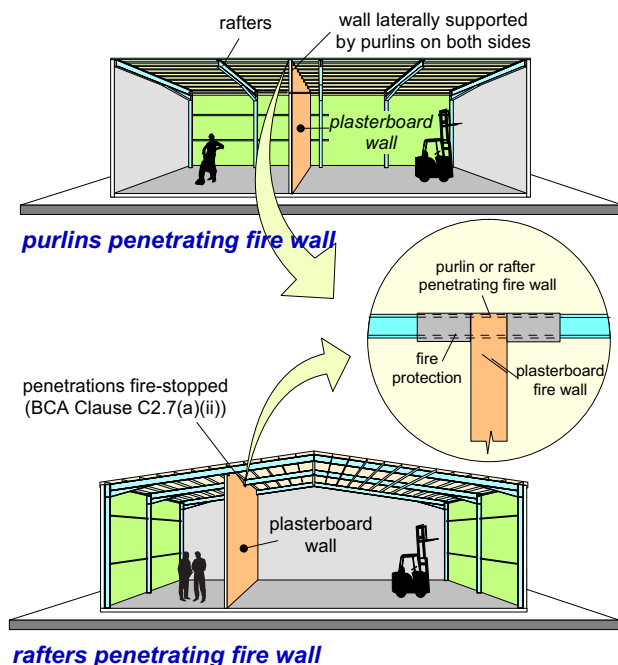
Figure 1

It is common for structural steel members to penetrate fire-resistant walls. The most common situation is where a steel frame or supporting column is located within a fire-resistant plasterboard wall and other steelwork such as purlins or beams must frame into this supporting steelwork. Inevitably, this results in steel members penetrating the envelope of the wall. Since steel is a good heat conductor, it is traditionally assumed that fire may spread between compartments due to excessive heat flow via the penetrating steel member. In the past measures have been taken to avoid this possibility, with penetrating members being fire-protected on each side of the wall. This can be expensive. Two situations are illustrated below.

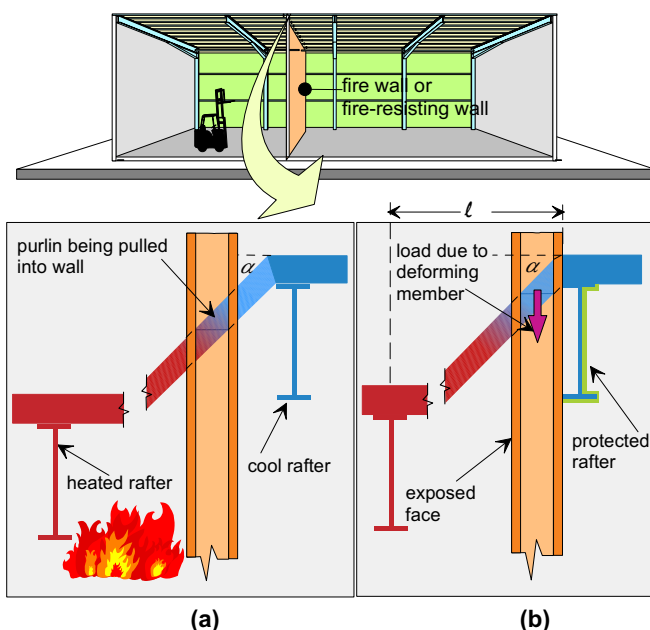
Figure 3

If the plane of a wall is perpendicular to the purlins, deformation of the purlins and rafters on the fire side of the wall may be sufficient to drag the purlins downwards into the wall as illustrated below.

This situation can be avoided as follows:

(i) locate the wall directly adjacent to a protected rafter (see Figure 3(b)) and allow sufficient space below the purlins for some movement (see detail in Figure 4(a)). The rafter adjacent to the fire wall must be protected, since fire may occur either side of the wall, or

(ii) incorporate steelwork within the wall capable of resisting the loads applied to the top of the wall. In this case the rafter does not need to be protected.

Assume that the purlin is supported by a rafter adjacent to the wall as per Figure 3(b) and that it is discontinuous at all rafter supports, attached to each rafter by two bolts. As the roof on the fire side of the wall is heated, the purlins will tend to heat more rapidly than the rafter due to their thinner steel section. They will thus expand and remain slack until the rafter deflects sufficiently for this slack to be absorbed. At this time the force in the purlin will increase rapidly, with shear failure of the heated bolts occurring shortly thereafter. The vertical component of the axial force in the purlin at this time will be the maximum force applied to the supporting structure. Assuming purlins and bolts to be at a temperature of 800°C, the angle to the horizontal (α) and the vertical component of the reaction force (P) can be calculated as follows:

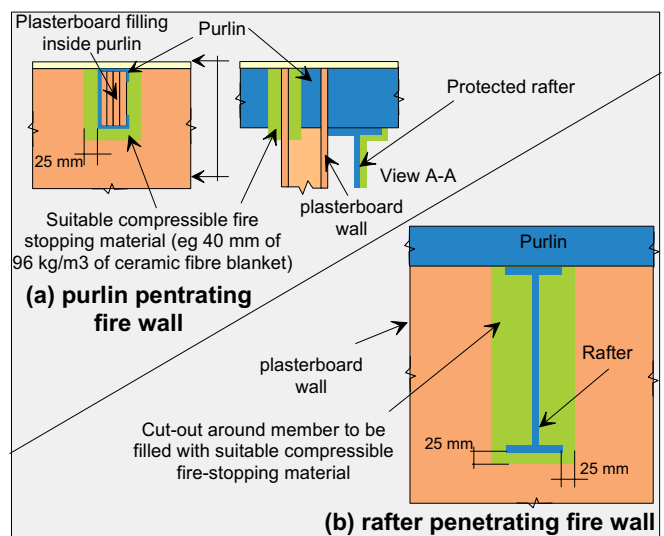
Figure 4

In cases (b) and (c), the fire stopping of the penetration through the wall must be done in such a way as to allow space for some deformation of the rafter (see Figure 4(b)).

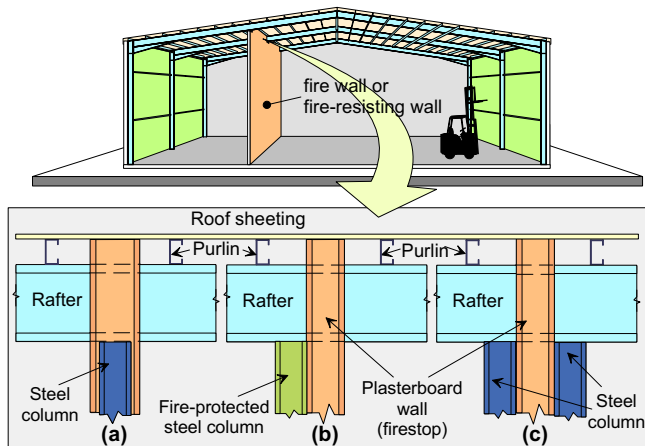
Figure 5

The second situation is where a unprotected steel rafter penetrates a wall (Figure 5). In this case, the structural adequacy of the wall can be achieved by:

(a) incorporating a steel column (plus beam above column if necessary) within the wall providing direct support to the rafter, or

- (b) using a protected column, on one side of the wall directly adjacent to the wall, or
(c) using an unprotected column on each side of the wall.

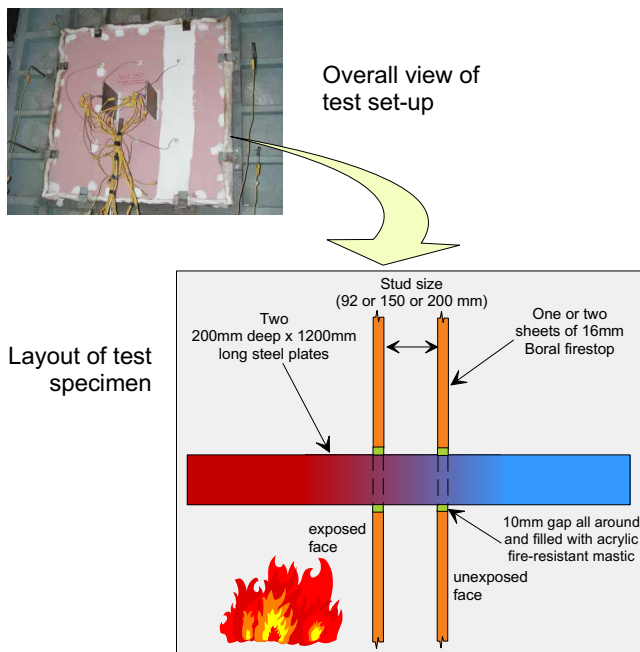
Figure 6

The tests were conducted in a fire test furnace which internally measures 2.1 m (width) x 1.8 m (depth) x 2.1 m

(height). The specimens were subjected to standard fire test durations of up to 180 minutes.

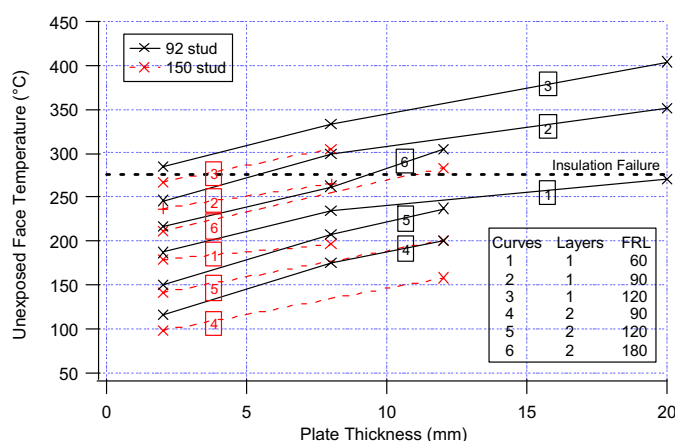
The relevant test results are summarised in Figure 8, which shows the measured unexposed face temperature versus thickness of penetrating plate at various times of fire exposure between 60 minutes and 180 minutes. The adopted insulation failure temperature of 275°C is also shown in this figure.

For the smaller stud size and a single layer of plasterboard, it may be seen from Curve 1 in Figure 8 that at 60 minutes all plate thicknesses up to 20 mm gave acceptable performance, with the unexposed face temperature below the adopted insulation failure temperature. Curve 2 shows that acceptable performance can be achieved at 90 minutes for plate thicknesses up to 6 mm.

For two layers of plasterboard, Curve 5 shows that acceptable performance at 120 minutes was achieved for plate thicknesses up to the maximum tested value of 12 mm. Since Curve 5 is below Curve 1 at this point, it seems reasonable to extrapolate these results and conclude that satisfactory performance will be achieved for plate thicknesses up to 20 mm. At 180 minutes, acceptable

performance was achieved for plate thicknesses up to 9 mm, as shown by Curve 6.

It may be seen from Figure 8 that the larger stud size produced lower unexposed face temperatures in all cases. However, these differences do not provide significant benefit near the limiting insulation temperature, and it is suggested that this effect be ignored.
