St. George's Terrace Perth

Unprotected Steel Beams

A rational fire engineering approach can offer significant cost savings by eliminating the need for passive fire protection of steel beams in high-rise building construction.

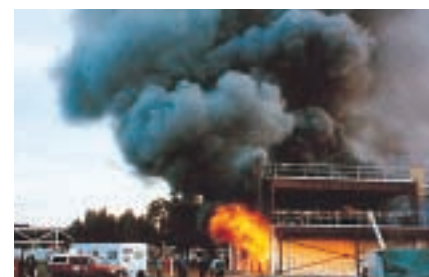
Fire test at BHP Research, Melbourne Laboratories.

The possibility of leaving the steel floor beams unprotected was first considered in relation to the building at 140 William St in Melbourne. The fire safety of this building was considered by BHP Research - Melbourne Laboratories using a combination of fire tests and a comprehensive risk assessment. Other detailed studies of the building structure were also undertaken and reports have been published.

It was also found from the fire tests that a significant fire resistance was offered by the unprotected steel floors. The building at 140 William St has been refurbished on this basis as have at least three other high-rise buildings in Melbourne. This has resulted in major cost savings.

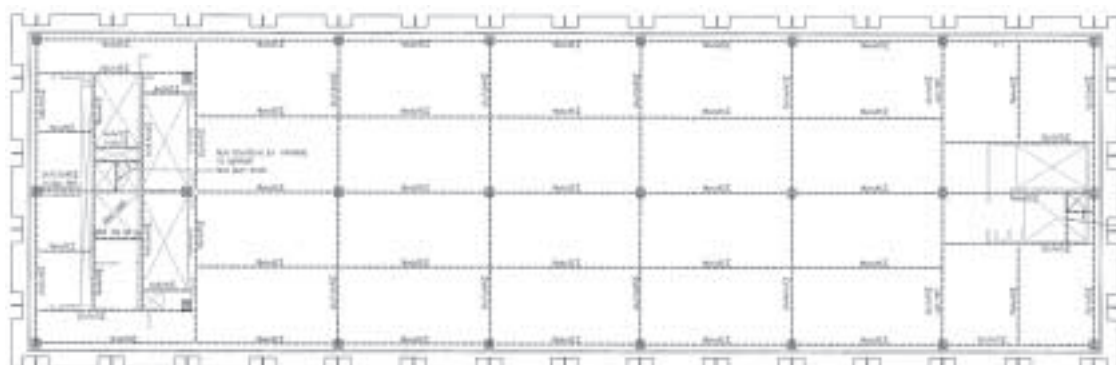
Top: Council House, Perth.

Right: 7th floor framing plan.

Typical floor construction consists of non-composite 115mm thick reinforced concrete slabs supported on 410UB60 secondary and 610UB140 primary beams with the beam grid being 7.5m x 7.75m.
