# Brisbane International Terminal

Structural Steel Development Group Issue number 14 November 1996

# **Brisbane International Terminal**

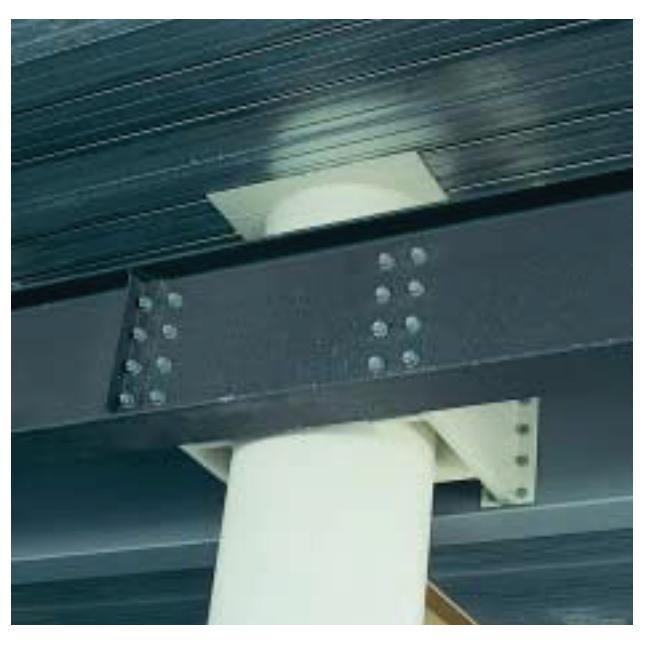
Beam to column connection.

Levels 2, 3 and 4 comprise 530UB82 twin primary beams which span 11.4m, continuous, in an east-west direction and support 360UB45 secondary beams spaced at 2.85m centres. Because the slabs were finished level and the beams were unpropped, the actual slab thickness varied up to 140mm in locations. Care was taken when levelling the wet concrete floor to account for any elastic deflection recovery of the floor beams as the construction load decreased on the span being poured. Since lateral load resistance in the direction of the primary beams (E-W) is by moment frame action, the primary beam connection to the column is required to be rigid. This is achieved by an assemblage of 32mm x 400mm deep steel plates which pass through the 610 OD x 12.7 and 9.5mm thick steel tube columns and are welded to the steel tube. The primary beams are connected to the steel plates by web side plates with 8M20 - 8.8S bolts.

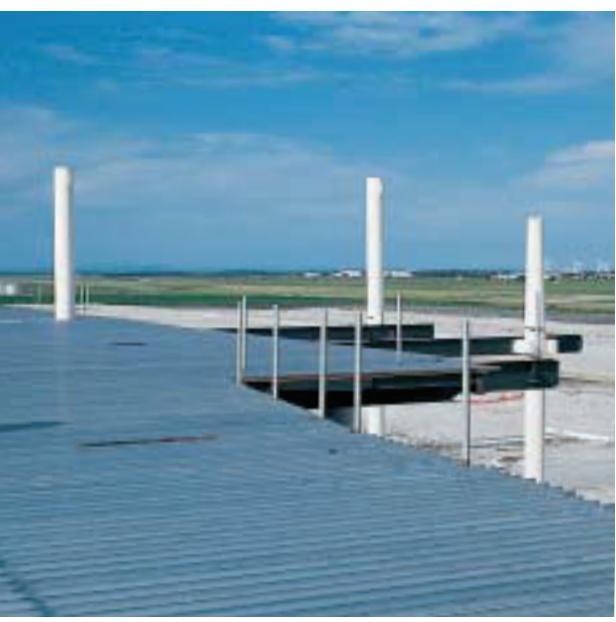
Steel columns and decking.

Approximately 42,000 square metres of 1.00mm Bondek II profiled steel decking was used in the terminal and associated works. Lateral load resistance in the N-S direction is provided by five bays of inverted vee bracing comprising steel CHS sections up to 457mm in diameter for the diagonal members and 310UC sections for the horizontal members at the floor level. Shear connectors transfer load from the floor into the bracing. Bracing connections generally comprise bolted gussett plates with 36M24-8.8S bolts, but pin joints are used in public areas for aesthetic reasons. The steel framed concept also extends to the lift wells which are framed in structural steel.

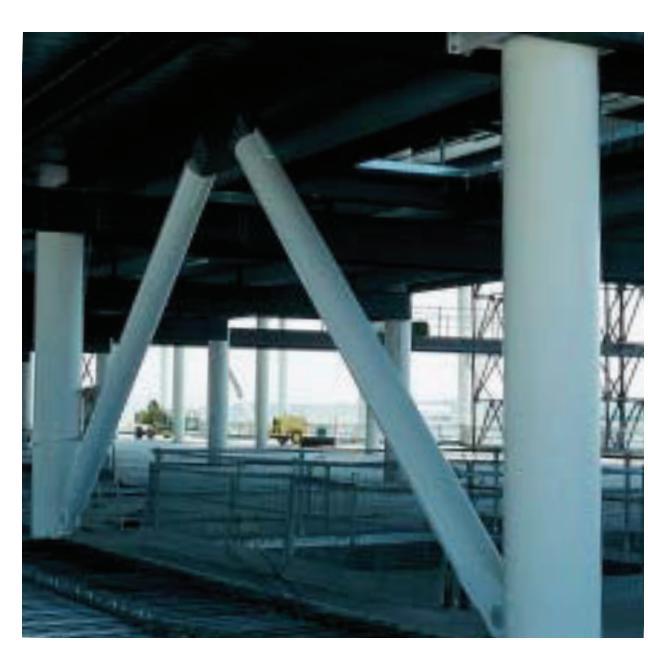
Steel wall bracing.

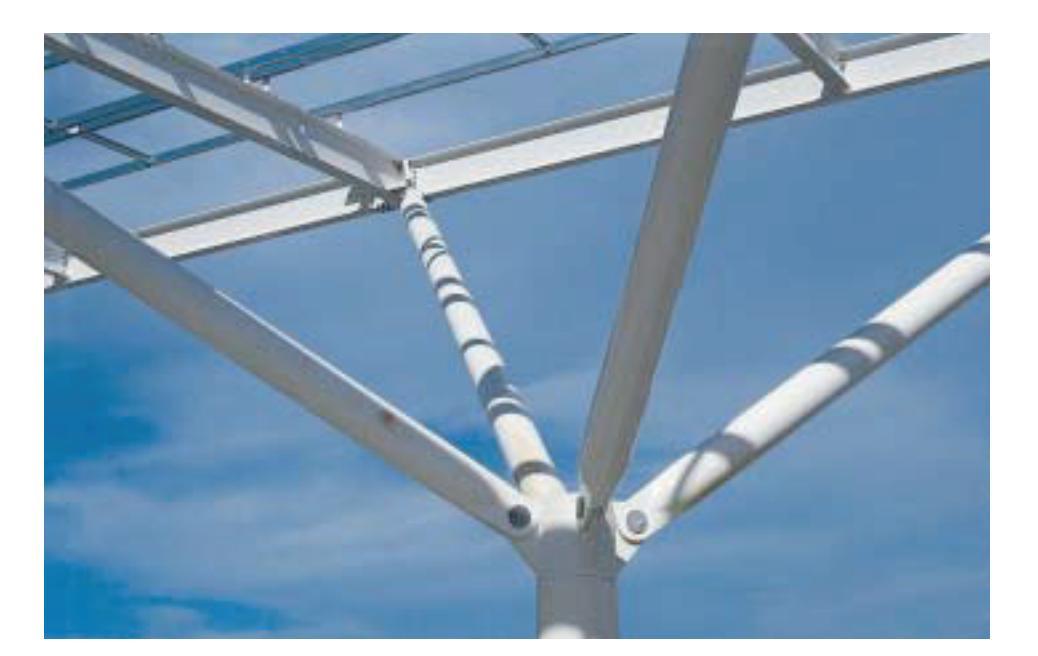
Right: Steel column 'trees'.

The steel roof structure comprises a grid of continuous universal beams supported at 11.4m x 10.2m centres by the branches of the column trees, with the supporting columns being on a 22.8m x 20.4m grid. Secondary roof beams running E-W reduce the purlin span to 5.1m. Continuity of the roof beams in both directions is achieved by high strength bolted joints and was necessary to create stability since the branches of the column trees are pin-ended. The columns supporting the roof taper from a 'trunk' of 610mm diameter at Level 4 floor to 425mm diameter at the top. The tree branches comprise 273mm diameter tubes with cast steel sections welded at each end to create a smooth transition from the tube to the tongue plates at each

connection. A 75mm diameter steel pin, contained by a 125mm diameter face plate each side, passes through the cast steel tongues and a 50mm thick gusset plate at the top of the trunk.

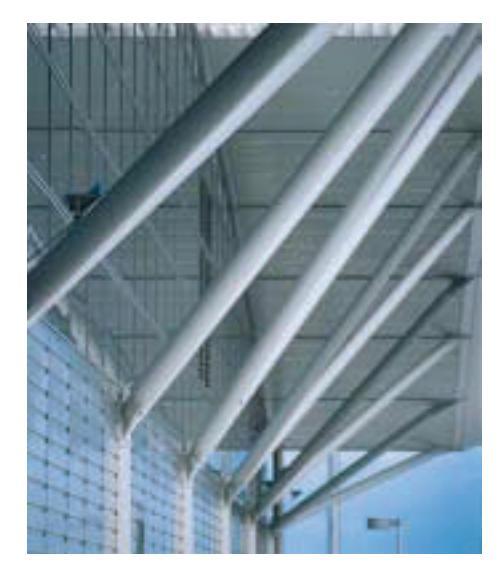
Below: Column branches and eaves overhang.

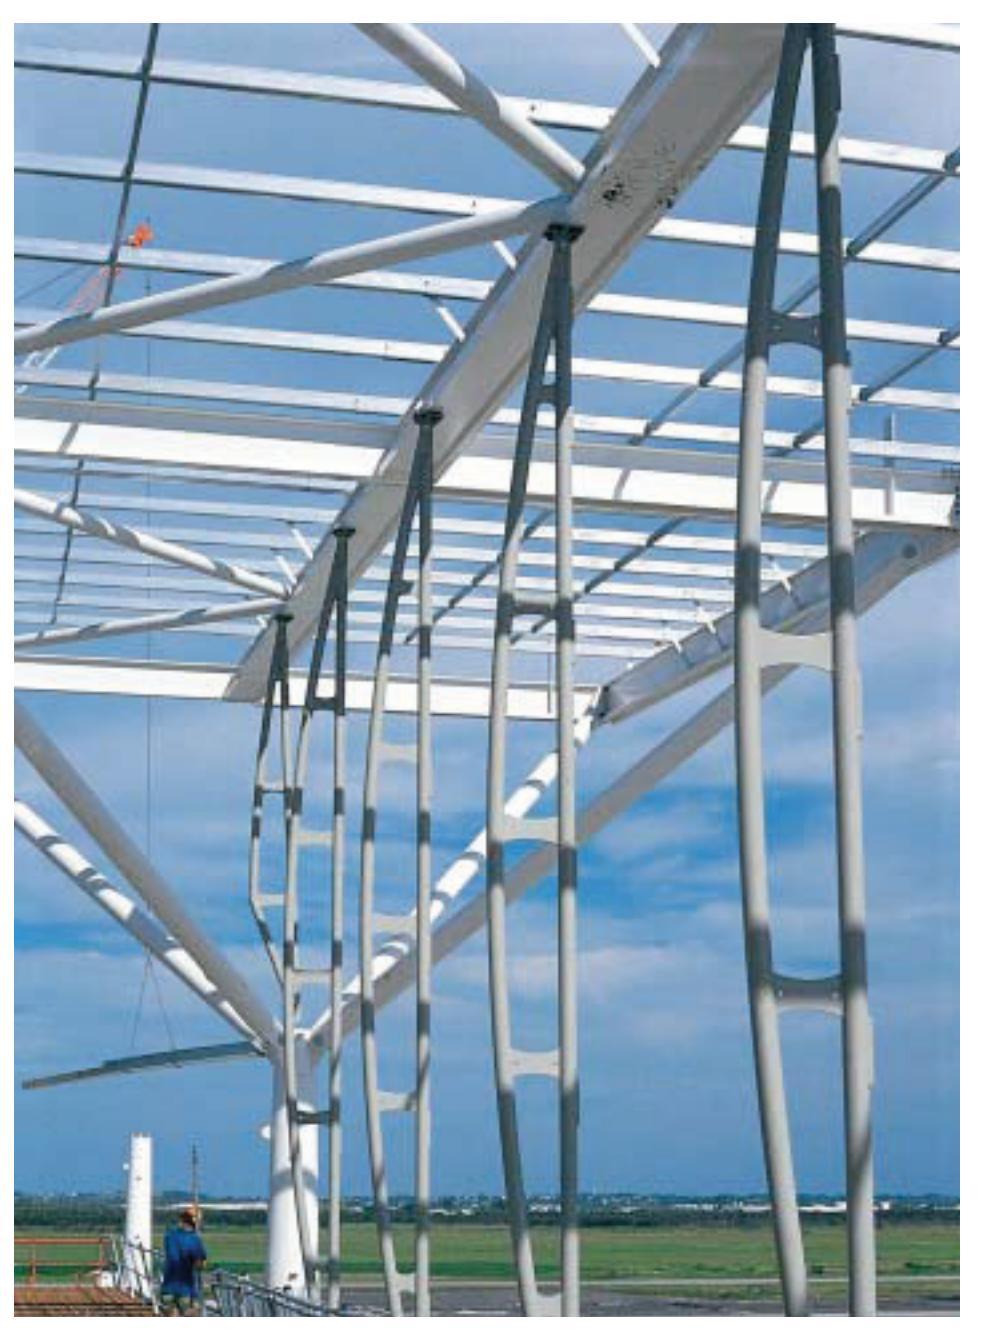
Right: Steel wall mullions.

The perimeter walls of the terminal comprise both glass and aluminium walling and steel cladding on steel framing. Vierendeel bowstring trusses spanning a maximum of 10.8m, and spaced at 3.4 to 3.8m centres, provide a lightweight appearance. The truss chord members are 89mm diameter steel tubes and the web members are 10mm plates; lateral bracing is provided by stainless steel wire strand ties at 2.4m centres vertically. Pin connections are provided at each end, continuing the theme of the column tree connections.

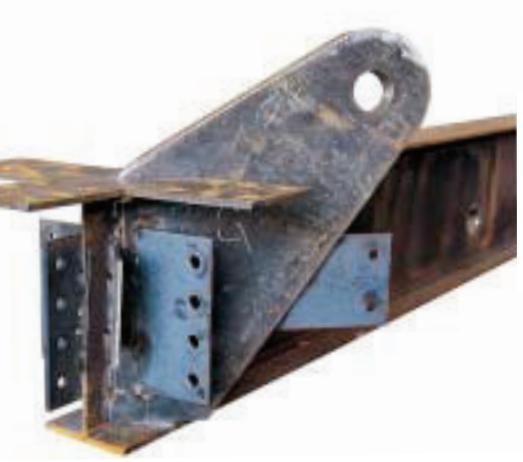
Left: Steel rafters during fabrication.

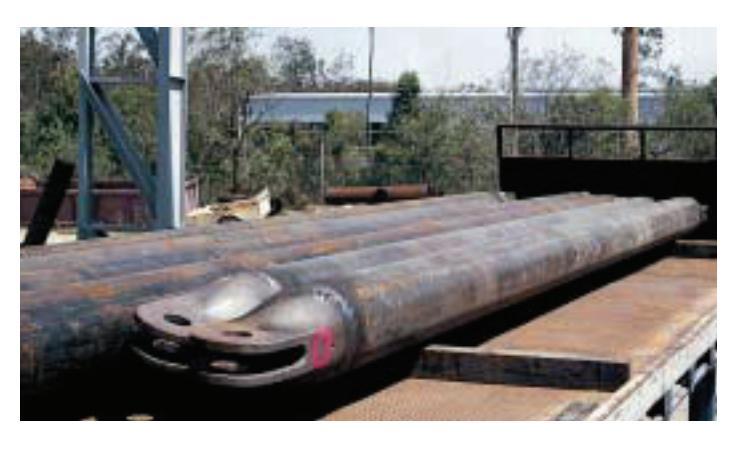
Below: Tubular steel roof struts.

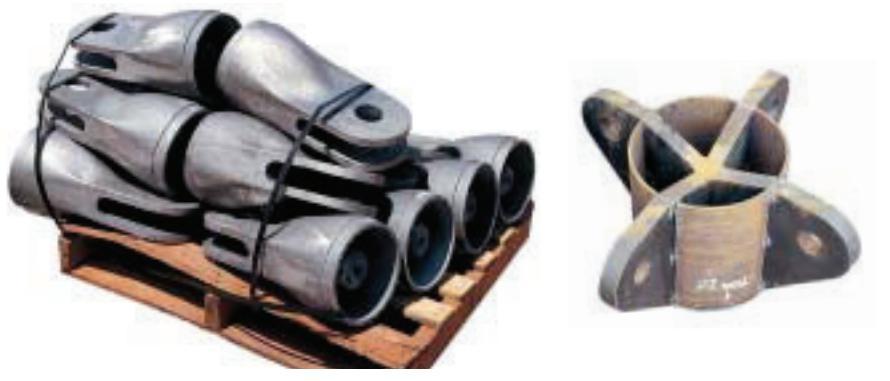
Far left: Cast steel roof strut end connectors.

Alfasi carried out further fabrication of the beams and the remainder of the steelwork in Brisbane, except for the stairs, wall mullions, and 'wire wall' which they fabricated in Melbourne. A feature of the terminal is the upper level tapering columns which have an elegant 'mouse ears' connection to the column branches. The connection comprises a baseplate and four inclined plates holed for a 75mm diameter pin, and was fabricated by Austin Engineering Pty Ltd. The smooth, streamlined transition between the column branches and the column trunk at one end and the rafters at the other end consists of a 225mm diameter steel casting. Austcast, of Brisbane, manufactured the pattern and produced a total of 332 castings at a cost of \$257 each.

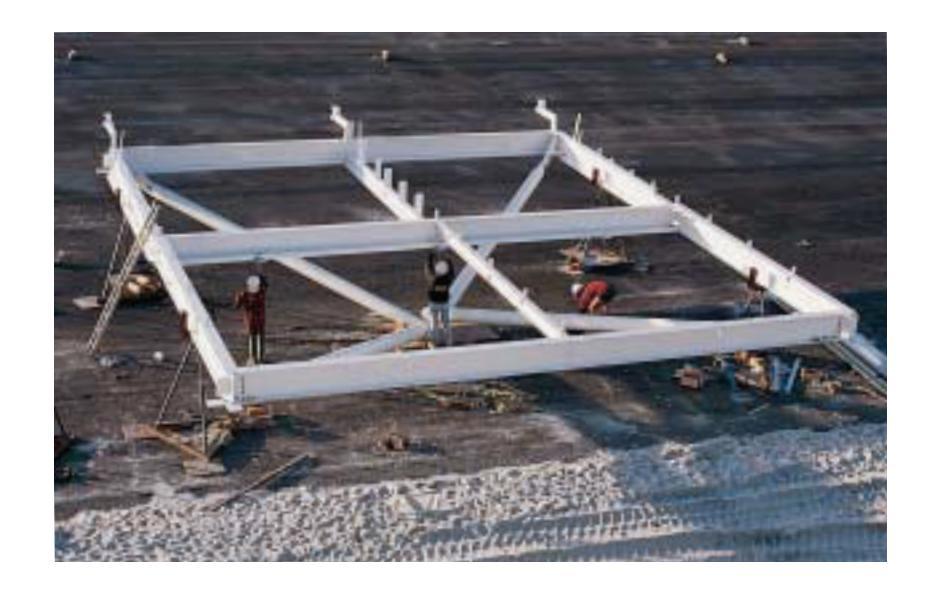
Left: Column to roof strut 'mouse ears' connection.

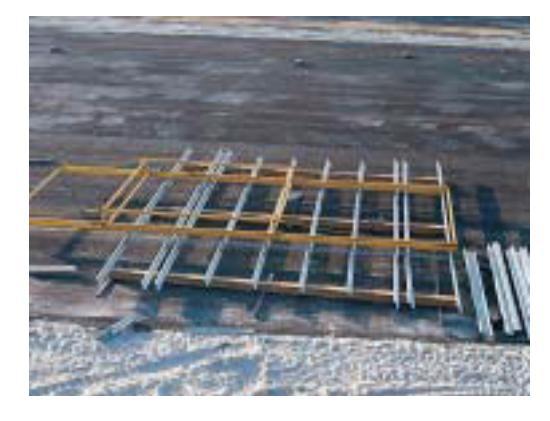
Right: Pre-assembled rafter panel.

a six week period of rain after Christmas. Typically  $2^{1}/_{2}$  bays at a time were erected with the crawler crane. The steel roof beams were pre-assembled in an 11.4m x 10.2m panel on the ground, complete with pin-ended column branches and purlins, then lifted into position, the branches then rotated into position and bolted to the column trunks. Roof purlins for the roof infill bays were also pre-assembled on the ground, lifted into position using a specially designed lifting frame, and bolted to the roof beam panel. All roof steel fitted together with no need for alterations on site.

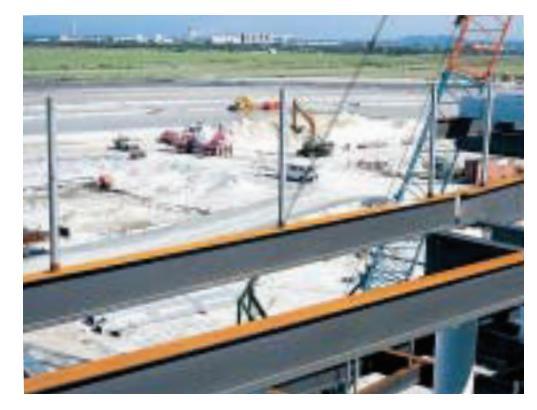
Below: Pre-assembled roof purlin panel.

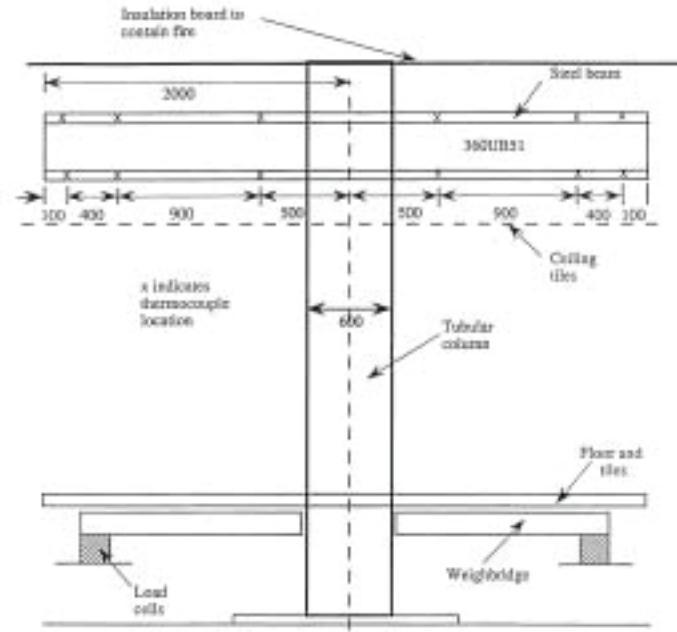
Figure 1. Beam and column set-up used for fire tests.

All tests incorporated a 610mm diameter circular hollow steel column having a wall thickness of 12.7mm, a 4m length of 360UB51 connected to the column, and a ceiling below the beam. This combination of column and beam (see fig 1) was incorporated in the test set-ups to provide a basis for assessing the likely performance of the terminal building structure in the unlikely event of a *non-sprinklered* fire. The tests also included sprinkler heads in the ceiling which were pressurised with air and a very small amount of water for the purpose of determining their likely times for activation.
